Boston Property Site Visit Eastern Mindanao, Philippines

Submitted to: Sentosa Mining Ltd.

Submitted by: Ronnie Therriault, M.Sc., P.Geo

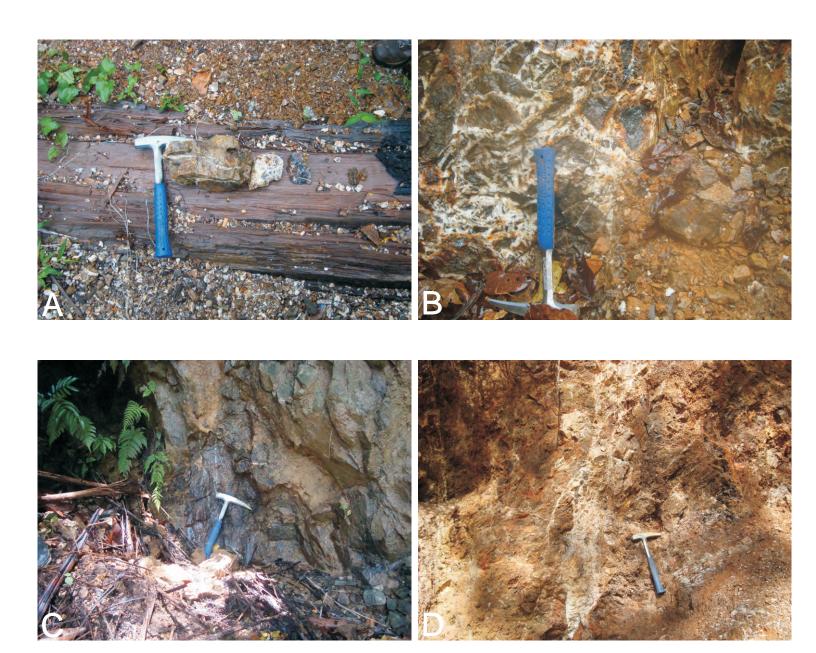
Plate 1: A) From left to right, sheeted veins cutting silicified sandstone, vein breccia with angular clasts of silicified sandstone, stockworked fine grained sandstone-siltstone; B) outcrop recently uncovered during a landslide (202671/877681). Clasts of silicified siltstone/sandstone in quartz matrix. Clasts on the right side of the photo are more strongly sulphidized and silicified fragments of sandstone(?) suggesting multiphase hydrothermal activity; C) sheeted veins at the entrance to the Valcorza adit; D) steeply dipping ENE vein breccia at the Block 2 adit.

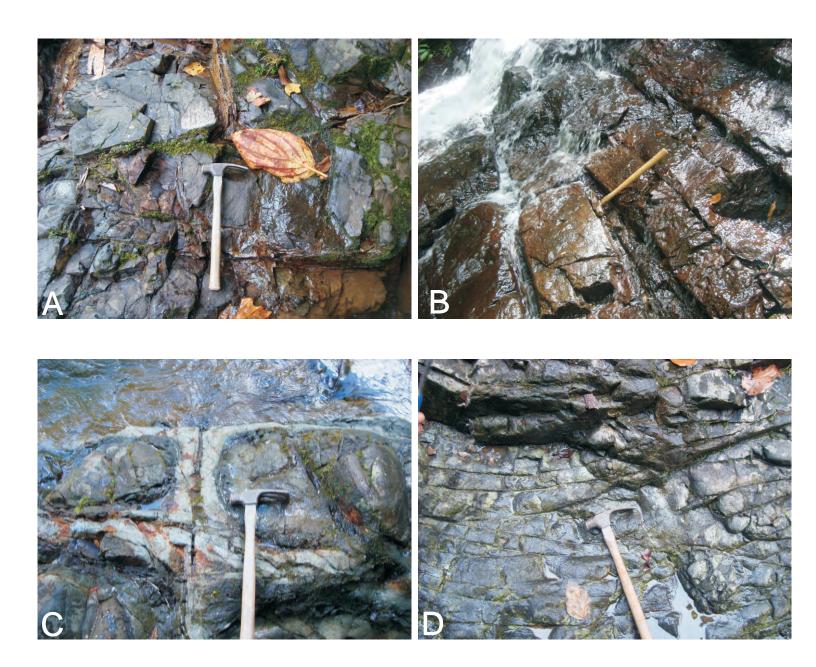
Plate 2: A) Conjugate cleavage sets controlling the distribution of silicification in drainage on Omega's property; B) reworked bedded intermediate crystal tuffs; C) pseudopillowed intermediate volcanics. Conjugate fracture sets have silicified and demagnetized selvedges; D) scour structures in bedded epiclastic sediments indicating tops to the NW.

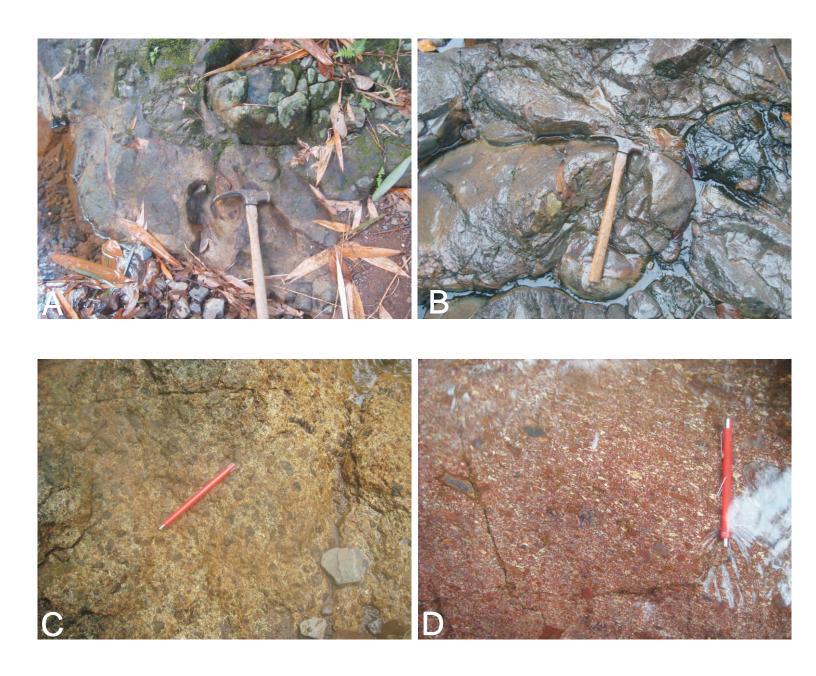
Plate 3: A) Fluvial conglomerate; B) pillowed andesite/basalt topping NW; C) likely a debris flow of some sort; D) andesitic volcaniclastic breccia.

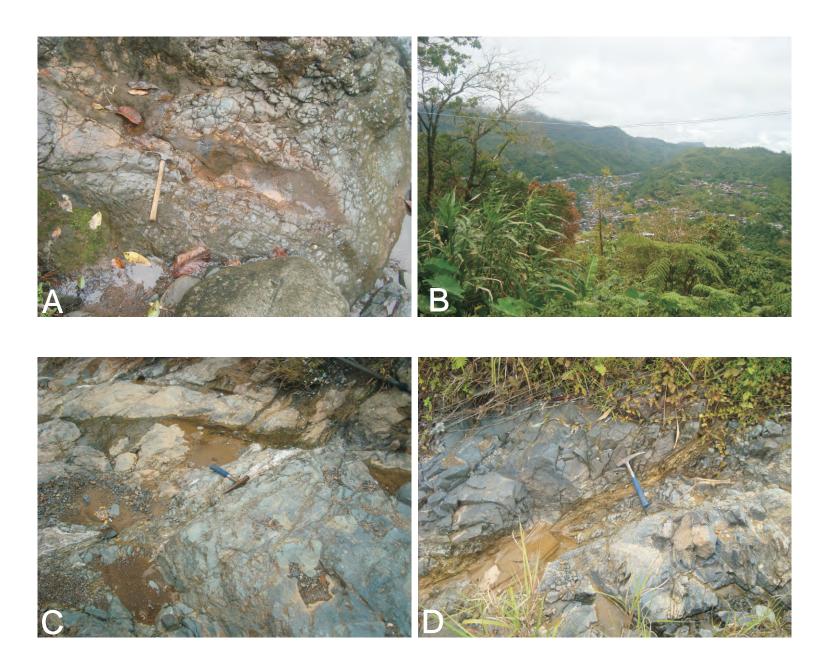
Plate 4: A) Basaltic pillows, sheeted flows and autoclastic breccia with interbedded pyroclastic material. Note peperitic textures toward centre of photo. Near adit on west side of northern Property; B) Diwalwal; C) faulted and veined contact between volcaniclastic breccia and porphyritic andesite flow/tuff, Diwalwal; D) Magnetic mafic dyke with faulted contact with andesite, Diwalwal.

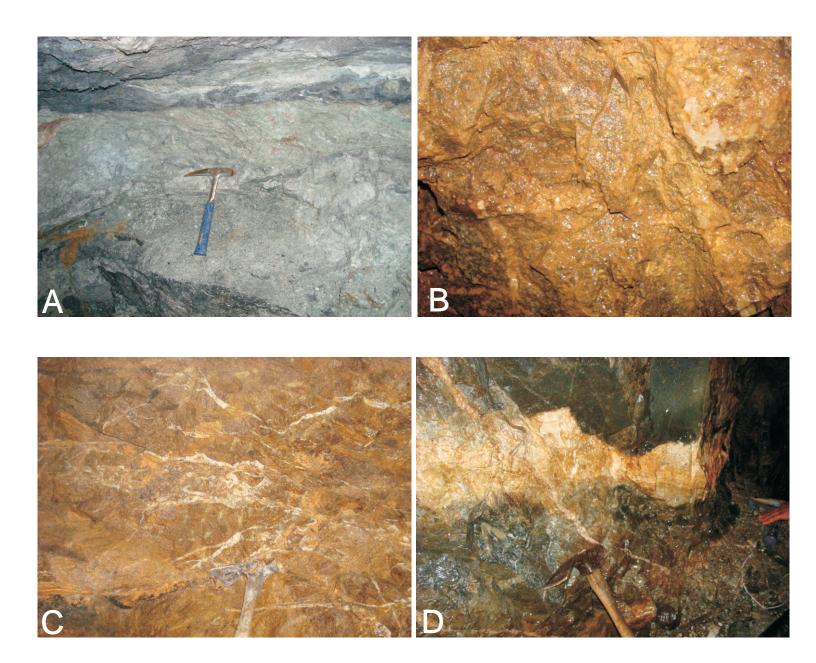
Plate 5: A) Low angle fault zone bordered by faulted quartz vein. The faults sometimes contain lithons of mineralized vein material, Laborte adit; B) low and high angle veins, Yugo adit; C) roof shot of vein orientations in the Yugo adit; D) offset limestone bed cut by small moderately dipping quartz vein, Laborte adit.

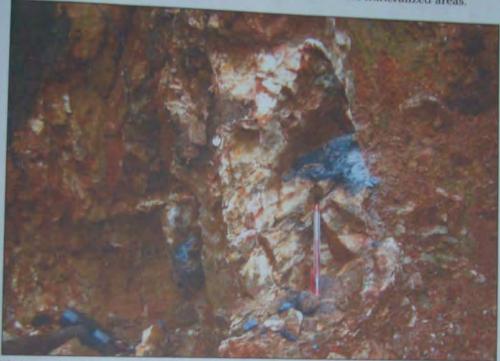
The auriferous quartz veins / vein breccia (Photograph 1) and associated alteration occur only in the metamorphosed sedimentary sequence. The andesite porphyry is chlorite altered and contains pyrite and perhaps some other sulfide species in areas close to the mineralized areas.

Photograph 1. Outcrop of limonite stained quartz vein breccia within the Boston Gold Project

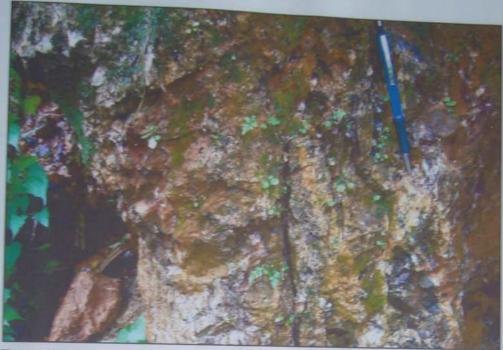
Photograph 2. Photo showing outcrop of limonite-hematite stained crystalline quartz vein/breccia exposed along trench BT-01 in Boston Gold project area (OM-051). Assays: 10.9 ppm Au, 7 ppm Ag, 8.0 ppm As

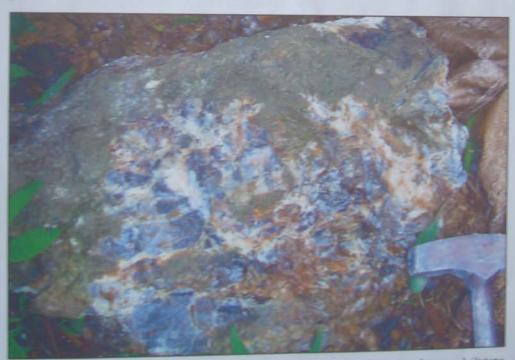
Photograph 3. Close-up view of the quartz vein breccia with angular clasts of silicified sandstone and silutone. Channel sample BT1 24-25 returned with 1.76 ppm Au and 5.4 ppm Ag.
